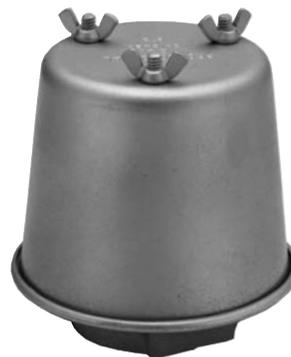
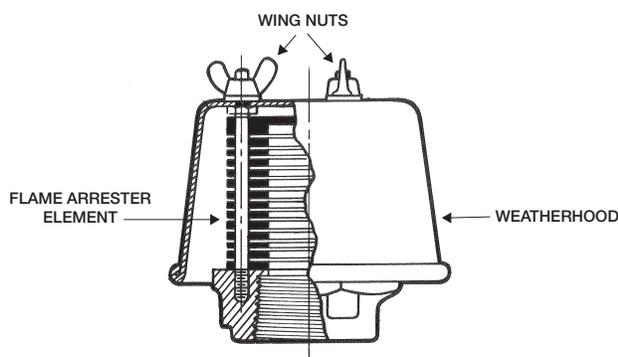
1. Loosen the wing nuts on the weatherhood. Remove the weatherhood to expose the flame arrester element.
2. The arrester element assembly consists of a series of circular plates, separated by precise embossed teats on the plates.
3. Inspect the arrester assembly. The passages between the individual plates should be clear. Blow out any loose dirt or foreign material. If necessary, the arrester assembly may be removed from the tank and immersed in a suitable solvent to remove gums and deposits. The ability of the arrester to stop a flame front is, in part, a function of the size of the openings between circular plates in the element assembly. If the spacings are not uniform, the arrester should be removed from service.

1. Check carefully to insure that no packing materials remain on or inside the vent housing.
2. Make sure that the wing nuts mounting the weatherhood to the housing are tightened securely.
3. Mount the vent to the appropriate outlet connection using sealant compatible with service conditions.
